# Manhole Inspection Summary

Manhole # S07AA1007MH

Insp Date: **7/2/07 9:28 AM**

**Location** Address: **3707 CHATAM RD** Cross Street: **AYREDALE AVE**

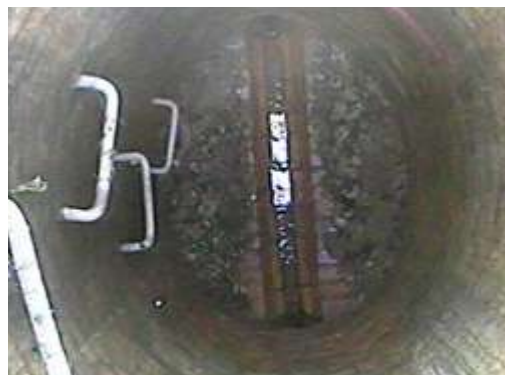
Top View

DEBRIS ON BENCH AND CHANNEL

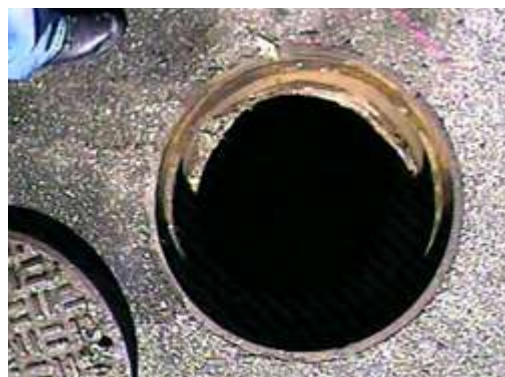
Defect 1

**Frame** Offset: **2** (in.) Condition: ☒ Sound ☐ Cracked ☐ Leaks

OFFSET FRAME

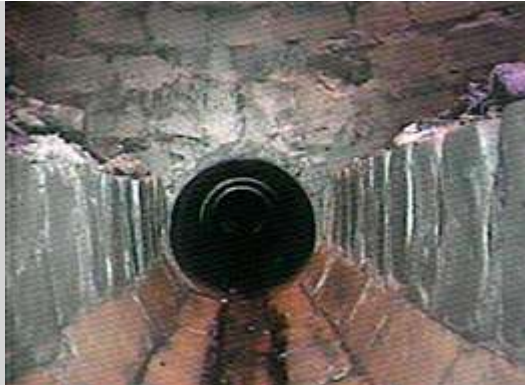
12 O'Clock Outflow

8 in. Circular Gravity Sewer  
Pipe Out @ 12 O'Clock

Infiltration: **None** Pipe Seal Cond: **Cracked**

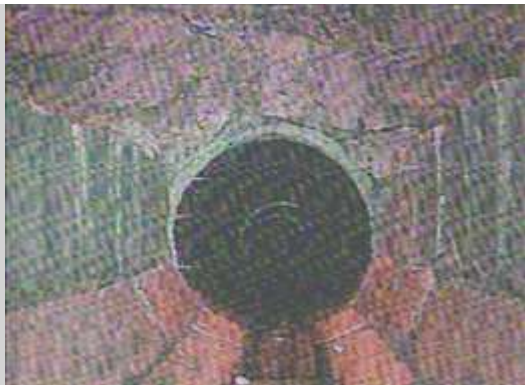
6 O'Clock Inflow

8 in. Circular Gravity Sewer  
Pipe In @ 6 O'Clock

Infiltration: **None** Pipe Seal Cond: **Cracked**
